NASA-TN-D-4894

BLAST SHIELDS TESTING

by Walter V. Medenica

George C. Marshall Space Flight Center

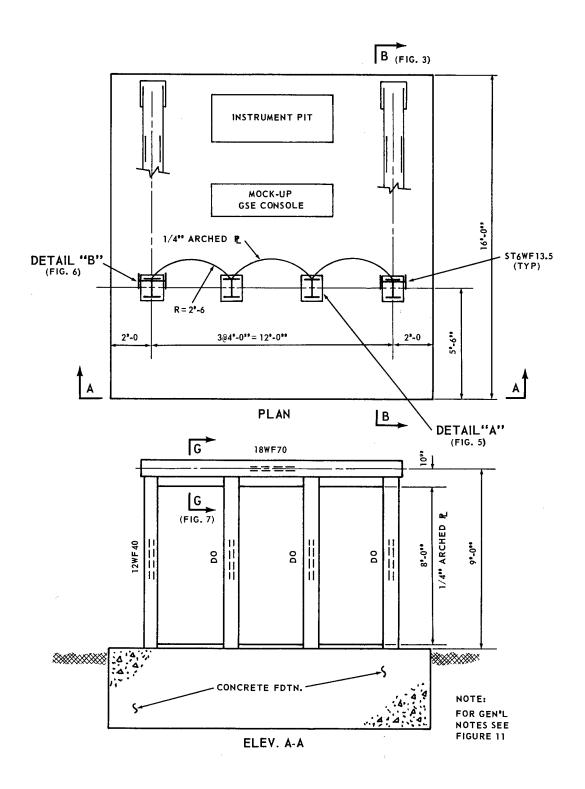
FIGURE 2. BLAST SHIELDS, ARCHED PLATES, PLAN AND ELEVATION VIEWS

- 1. Top horizontal beam (18 WF 70, Fig. 2) is simply supported.
- 2. Modulus of elasticity of the blast shields and the supporting structure is $E=30\ 000\ 000$ psi.
- 3. Solid arched plates and angle deflector, together with the supporting structure (All 12 WF 40 and 18 WF 70 beams; Figs. 2 and 13), offer their full projected area to the resistance of the blast forces.
- 4. Projected solid area of wire screens is added to the full area of the supporting structure to give the blast resisting area.

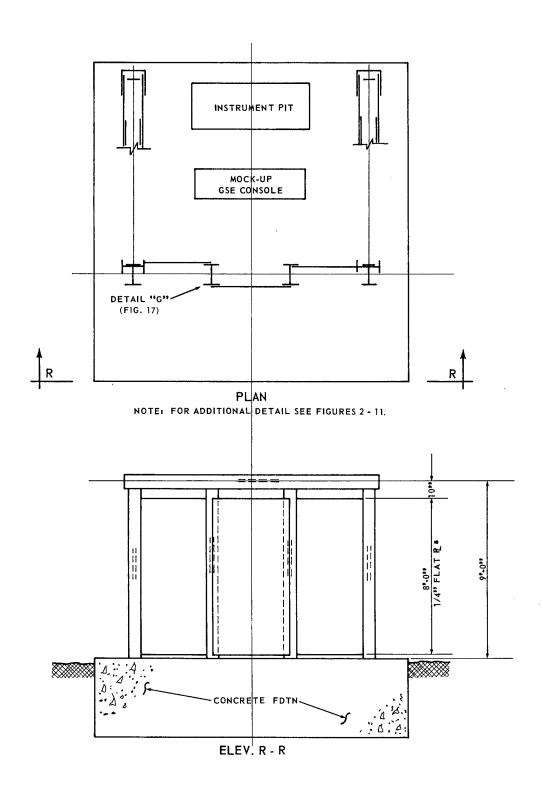
FIGURE 16. BLAST SHIELD, FLAT PLATE, PLAN AND ELEVATION VIEWS $\,$

Solid flat plates (Table II, Figs. 16 and 17) were introduced into the program as a simpler version of solid arched plates. They were expected to deform plastically under blast, similar to explosive forming, absorb energy in the process, and finally assume the shape of the arched plates. Unfortunately, none of the blasts to which flat plates were exposed was of a higher yield, and none was instrumented. Instead of a hoped-for deflection of 10 to 12 inches above the chord, no explosion produced a deflection greater than 2 inches. But even these low yield explosions and low deflections of the plates cracked open the bottom welds of the plates. Since similar cracking of welds occurred also during blast testing of the pre-formed arched plates (Fig. 23), closer attention should be paid to connection details of both the flat and the arched plates in future testing and application. The connection between this type of

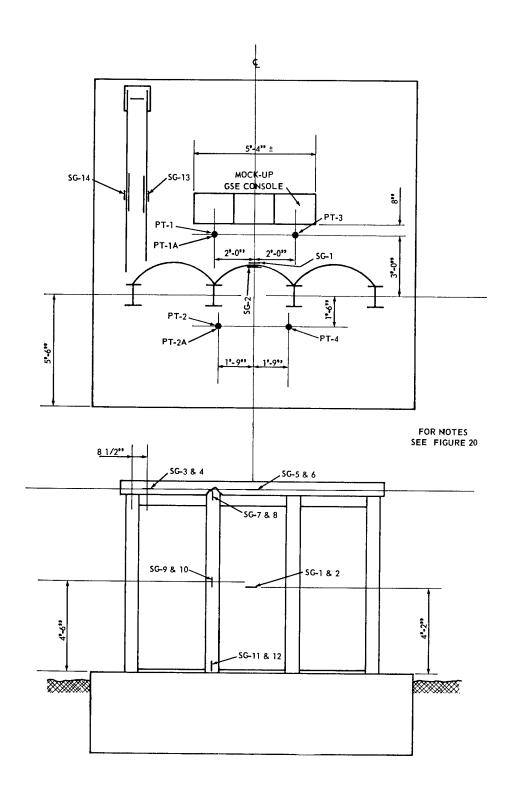
FIGURE 19. LOCATION OF INSTRUMENTATION

It will be noted on Figure 24 that traces of pressure transducers PT-2 and PT-4 indicate two peaks of practically equal magnitude, one immediately before and one immediately after PT-1 and PT-3 reached their peaks. The first peak on PT-2 and PT-4 is the reflected overpressure from the blast shield and the supporting structure; the second peak is the reflected overpressure from the GSE consoles (Fig. 19).

Traces of strain gauges SG-1 and SG-2 on the arched plates (Fig. 19) do not show only tension, as one might expect, but a succession of tension and compression. The reason for this is the arched depth of the plate (approximately 12 in.). The shock front and the reflected overpressure, from the front and from the back, reached different parts of the arched plates at different times, causing bending moments in the plate with consequent alternating stresses.

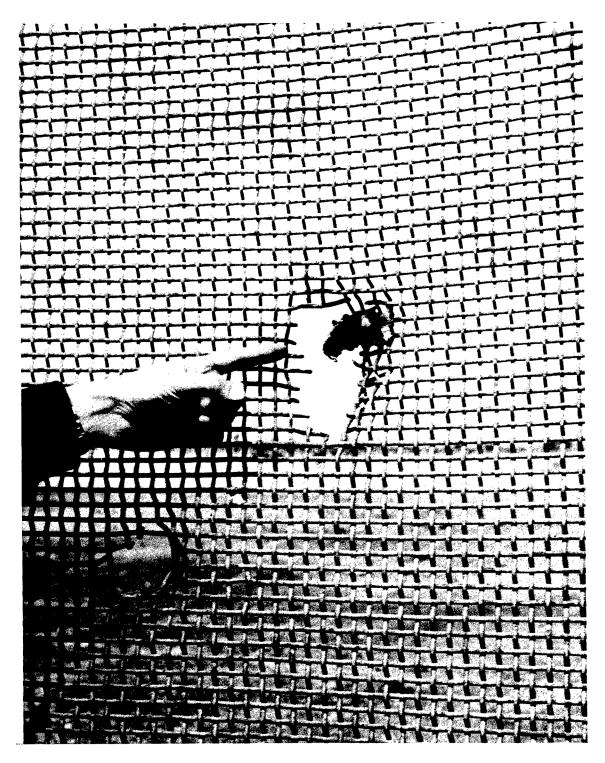
FIGURE 22. SHRAPNEL PERFORATION OF WIRE SCREEN, TEST 301

The relative effectiveness of wire screens with less than 50 percent open area is not clear. Here again, a few more tests would give the answer. For the time being the only actual benefit one could expect from wire screens is a certain protection from light flying fragments. The tested wire screens which survived the blast well still were perforated by flying fragments (Fig. 22).

This Titan I test (Fig. A-12) of low explosive yield caused slight damage to Wire Screen No. 2, and no damage to the angle deflector (Figs. A-13 and A-14). Some holes were perforated in the wire screen by flying fragments, and some bottom wires were ripped loose from their welded connections. Here again the failure occurred at the most rigid location of the blast shield as was the case with arched and flat plates.

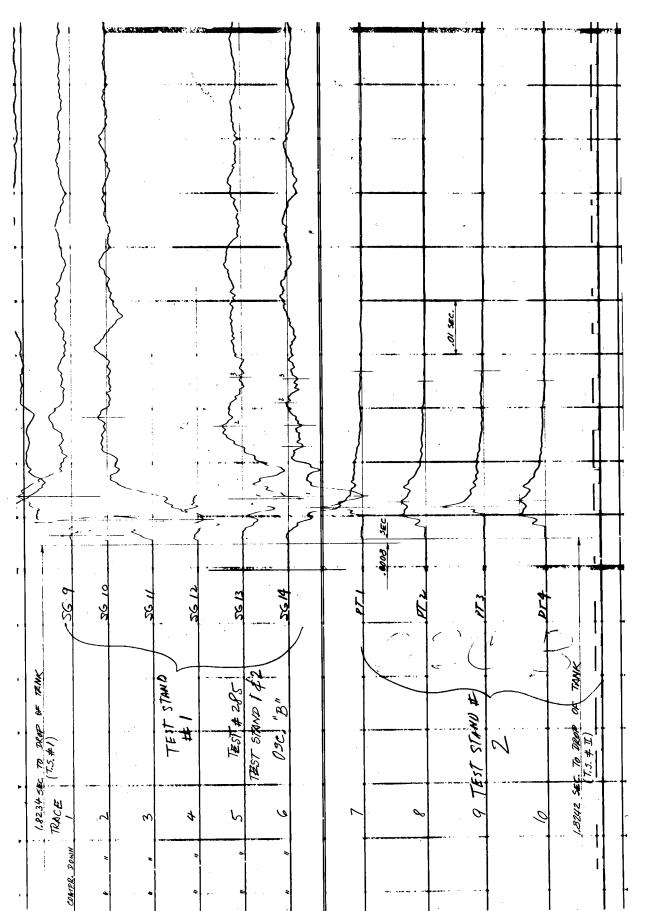
FIGURE 24. SAMPLE OF RECORDER OSCILLOGRAPHS, TEST 285

This structural evaluation is based on recorded strains at the first highest peak of the same sign (tension or compression). As Figure 24 shows, the first highest peak of the same sign is usually the highest of all. This, of course, is to be expected, except in cases where the material under the strain gauge goes into the plastic region, as was the case with strain gauges SG-11 and 12 on Figure 24.

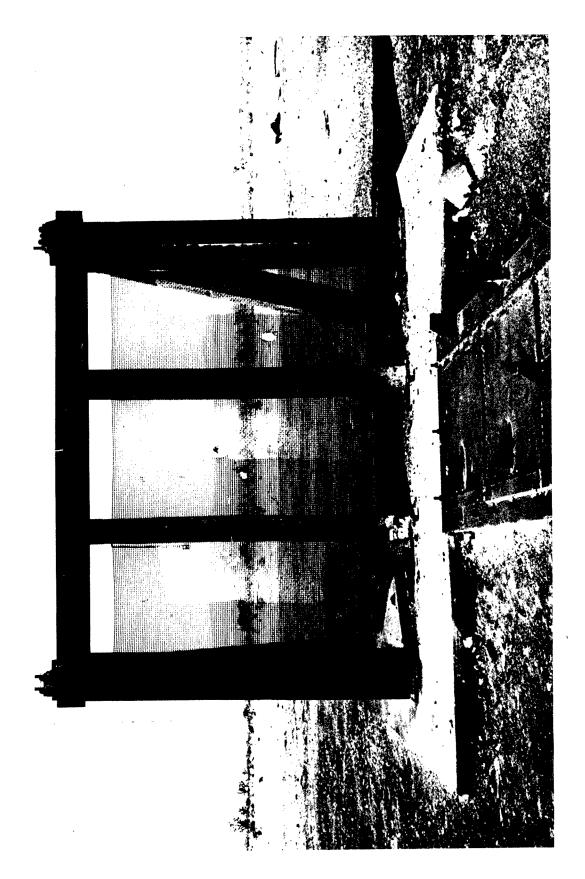
FIGURE A-14. TEST STAND NO. 2 AFTER EXPLOSION, TEST 301 (BLAST SHIELD: WIRE SCREEN NO. 2 WITH 48.0% OPEN AREA)

The same, damaged, GSE cabinets from Test 300 were exposed to blast again in this test. The shedding vortices of the overpressure wave around the blast shield, and the momentary higher overpressure behind the cabinets, pushed the cabinets against the blast shield. It is surprising that they were overturned now, and not during the stronger blast of Test 300. The reason for this is the weakening of anchorage during Test 300, so that relatively small overpressure was sufficient to overturn them during Test 301.
